Report Number:	PPR-3431		
Issue Number:	2	Issue Date:	March 2019
BCIC PRODUCT FIELD SAMPLE CASE STUDY REPORT			
Author:	Matt James Product Specialist, EMEA

TE Connectivity (Raychem) BCIC bushing connection insulation cover was removed from its substation in Durban for investigation into the products degradation and material performance assessment after 12 years in service. Summary of testing evaluating the materials visual, mechanical and electrical performance after its successful operational service life in comparison to a new product. Correlating the current material qualification and performance including a predicted service life performance against a real in-service product which has been exposed to 12 years of high temperatures, high UV and day to day airborne pollutants situated by the coast.

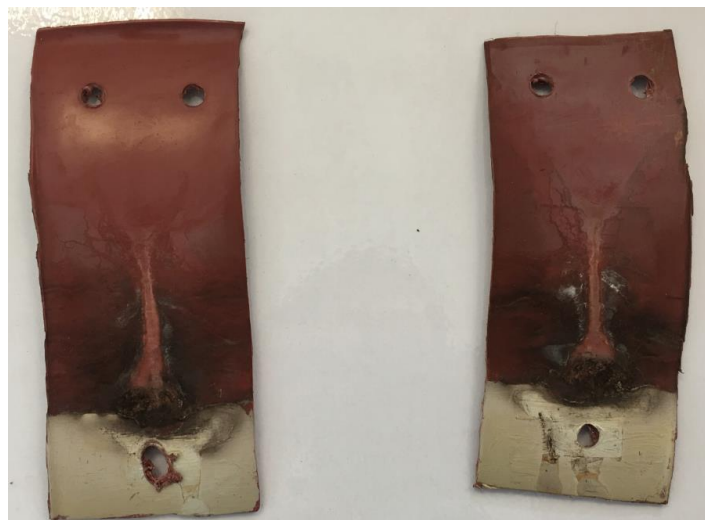
Figure 7 Tracking and Erosion Test Samples Post 5 hours ASTM 2.5kV Step Test: (left) BCIC Control Product; (right) BCIC In-Field Service Product

The voltage and time at failure mode are recorded.

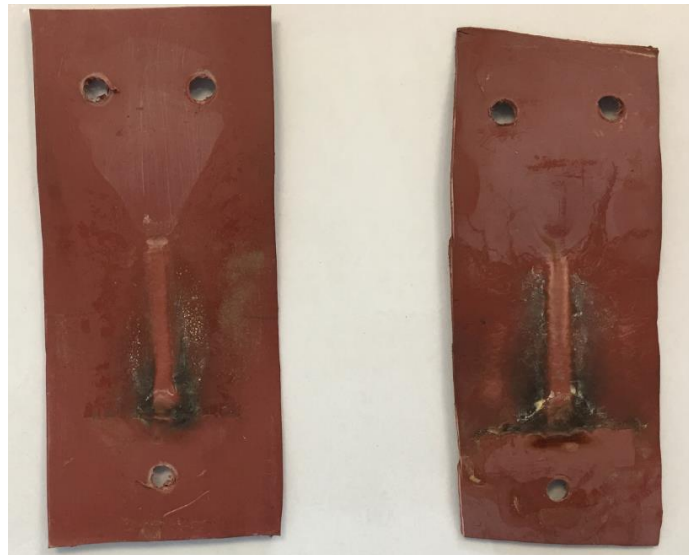
Figure 8 Tracking and Erosion Test Samples Post 6 hours IEC 4.5kV Constant Test: (left) BCIC Control Product; (right) BCIC In-Field Service Product

Experimental test method and sample preparation are the same as that as for the ASTM D2303 except as can be seen there is no silver paint applied to the material where the bottom electrode is located.

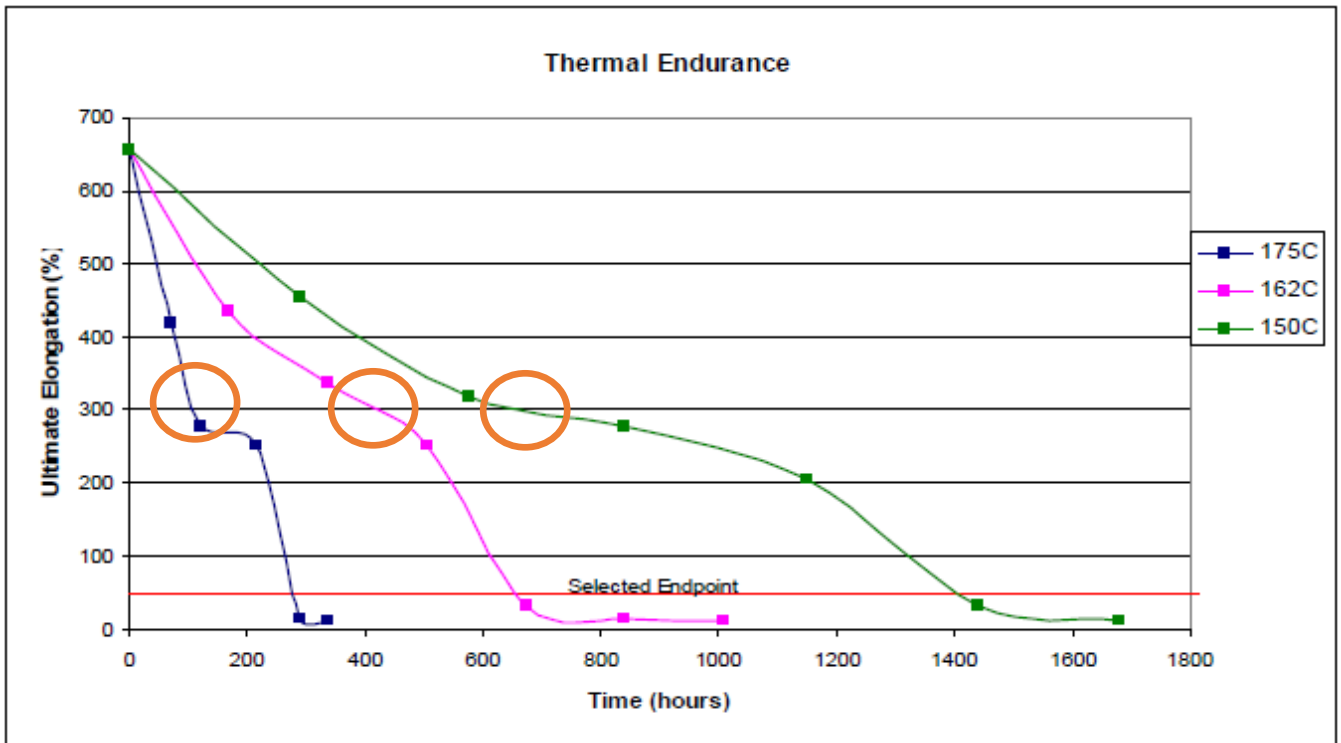
Figure 9 Thermal Endurance, 3 tested temperatures showing the elongation at break values vs time; tensile performance of the in-service field sample has been marked on the 3 traces

Thermal Endurance test results taken from PPR-3326 in accordance to IEC 60216, defined as the continuous service temperature at which the material will last 20,000 hours was found to be 115°C. The results were based on three aging temperatures 150°C, 162°C, and 175°C and the elongation at break values at sequential take outs are shown below. The tensile test results from the field sample have been plotted on the same graph indicated with orange circles. This shows that the material is around 45-50% through its expected service life, resulting in a 24-26 year service.

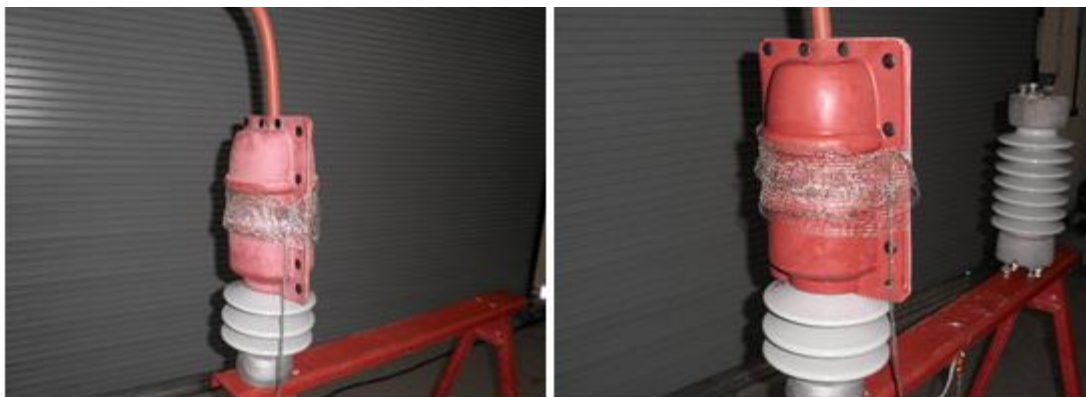
Figure 10 AC Withstand Test Set up showing the product with 12 years in-field service (left), which is heavily contaminated with residue on the inside and outside and new unexposed cover (right), the steel mesh represents a ground plane

The withstand test was performed in accordance with IEEE std. 4a-2001. A wire mesh was wrapped around the outside of the cover. The voltage was then brought up to 20kV (34kV ph-ph) and held for 1 minute. The voltage was then raised 2kV per minute until a flashover occurred.

Both covers passed 20kV (34kV ph-ph) for 1 minute. The new cover flashed at 31kV (53kV ph-ph) through the bottom of the cover and the field cover flashed at 30kV (52kV ph-ph) through the bottom.
